**Flood Control Project Maintenance  
Levee Inspections**

## Maintenance Issue Types Only, Levee Inspection Report By Mile - Spring 2017

### Sutter Maintenance Yard East Levee Sutter Bypass

Waterway	Bank	Unit Miles	Inspection Start/End	Inspector
Unit No. 01 Sutter Bypass Levee	Left	21.68	04/13/2017 04/13/2017	Bob Duffey

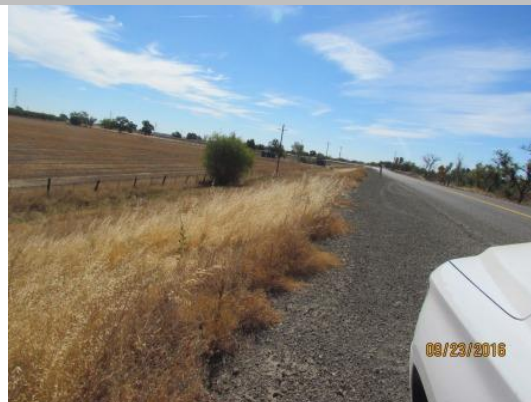
Photo 1 of 1 : SP\_2017\_ST0002\_450\_27\_20170315\_00006.jpg

LM Start	0.01	Rating **	M	Issue No.	27
LM End	0.33	Issue Type +	Ma	Location *	LS
Category	Earthen Levee			GPS Latitude/Longitude	
				Start	End
Item	Vegetation			39.151117 °	39.147405 °
				-121.831953 °	-121.828543 °
DWR ID	DWR_ST0002_01_f_2016_27				
Comment Code					
V1 : Control annual grass and weeds on the levee slopes and easements.					
Inspector Comment

View of the annual grass blocking visibility.

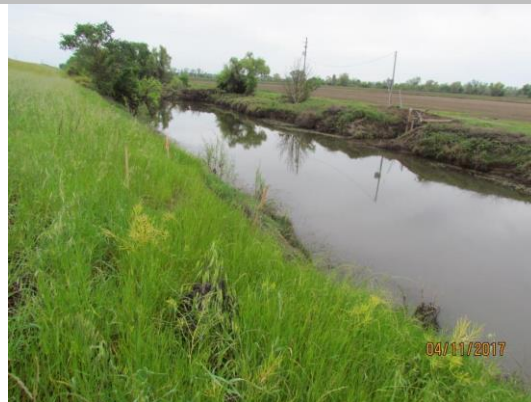
Photo 1 of 1 : SP\_2017\_ST0002\_450\_42\_20170413\_00069.jpg

LM Start	0.36	Rating **	M	Issue No.	42
LM End	0.36	Issue Type +	Ma	Location *	WS
Category	Earthen Levee			GPS Latitude/Longitude	
				Start	End
Item	Erosion / Bank Caving			39.147183 °	39.147183 °
				-121.828142 °	-121.828142 °
DWR ID	DWR_ST0002_01_s_2017_42				
Comment Code					
E1 : Note and monitor erosion site.					
Inspector Comment					
Repair the erosion along the water side toe.

View of the erosion along the waterside toe.

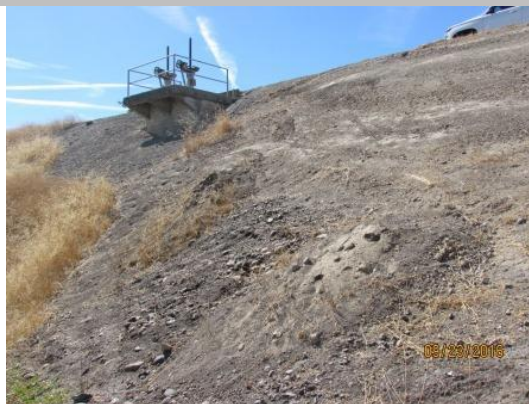
Photo 1 of 1 : SP\_2017\_ST0002\_450\_30\_20170315\_00008.jpg

View of the rodent holes along the landside slope.

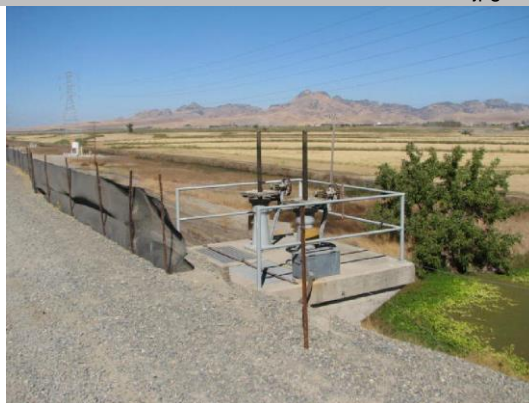
Photo 1 of 3 : UCIP\_SP\_2017\_51566\_64815.jpg

FS\_ID:51566  
DS\_ID:16880  
EP\_NO: N/A  
Repair Type: No Action Needed  
Crossing Status: Found  
UCIP Comments: 4/11/2017 Not abandoned. good condition. (DWR Sutter Yard- AFreitag)10/10/2016 NOT ABANDONED. The old pumping plant was removed but the culverts are still used as a gravity drain to regulate the water level in the LS ditch.(DWR Sutter Yard - afreitag)4/18/2016 Crossing is in good condition. The culvert is not abandoned and is used as gravity drain for the LS ditch into the bypass channel.5/7/2015 Concrete culverts are still being used as gravity drains for the LS ditch.11/12/2014 Same as last inspection.5/13/2014 Same as last inspection.10/30/2103 Same as last inspection.5/22/2013 Concrete culvert is being used as gravity drain for LS ditch.10/8/2012 Flap gates left in open position. Unable to determine type of abandonment for concrete culverts. Contact inspector to determine type of abandonment.

Slide gates on LS shoulder.

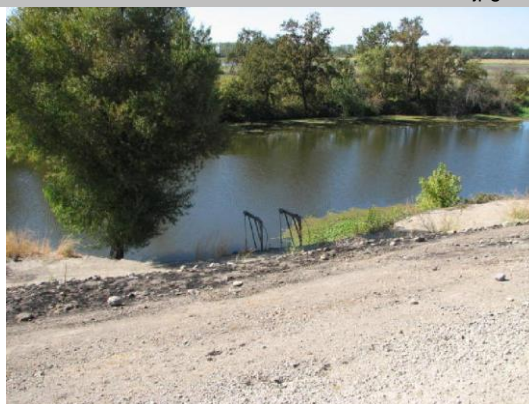
Photo 2 of 3 : UCIP\_SP\_2017\_51566\_64814.jpg

Flap gates on WS toe.

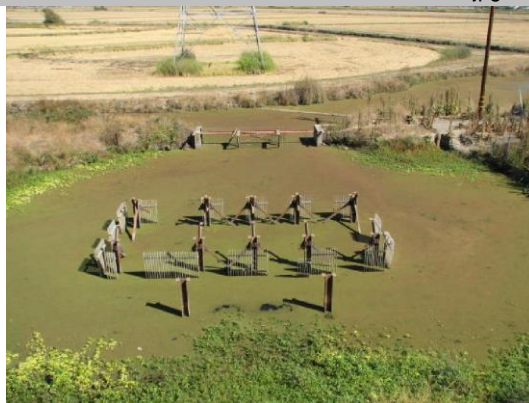
Photo 3 of 3 : UCIP\_SP\_2017\_51566\_64813.jpg

Abandoned pumphouse and sump on LS toe.

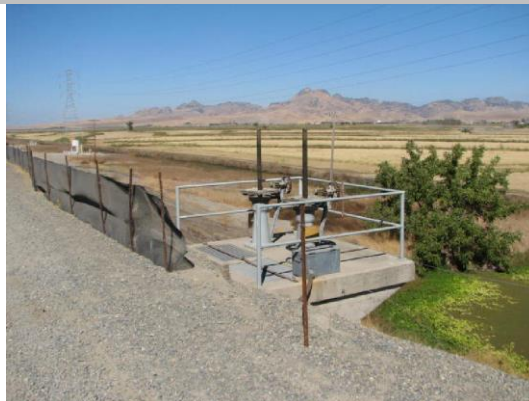
Photo 1 of 3 : UCIP\_SP\_2017\_51567\_64819.jpg

FS\_ID:51567  
DS\_ID:16895  
EP\_NO: N/A  
Repair Type: No Action Needed  
Crossing Status: Found  
UCIP Comments: 4/11/2017 Not abandoned. Good condition. (DWR Sutter Yard- AFreitag)10/10/2016 NOT ABANDONED. The old pumping plant was removed but the culverts are still used as a gravity drain to regulate the water level in the LS ditch.(DWR Sutter Yard - afreitag)4/18/2016 Crossing is in good condition. The culvert is not abandoned and is used as gravity drain for the LS ditch into the bypass channel.5/7/2015 Concrete culverst still being used as gravity drains for LS ditch.11/12/2014 Same as last inspection.5/13/2014 Same as last inspection.10/30/2103 Same as last inspection.5/22/2013 Concrete culvert is being used as gravity drain for LS ditch.10/8/2012 Flap gates in open position. Need to determine type of abandonment. Contact inspector to determine abandonment.  
FIELD\_STRUCT\_DESC: \*ABANDONED\* [Pumping Plant No. 3] 2 of 2. 4-foot by 6-foot concrete drainage culvert through the levee, 30 feet below the crown. Slide gate in concrete well on the landside (LS) shoulder. Wood flap gate and concrete headwall on the waterside (WS) end. Abandoned State pumping plant on the LS. [Additional Reference(s): DWR Levee Log, 2005. USACE Sacramento O&M Manual 315, May 1953 (Station 966+30)]

Slide gate valves on LS shoulder.

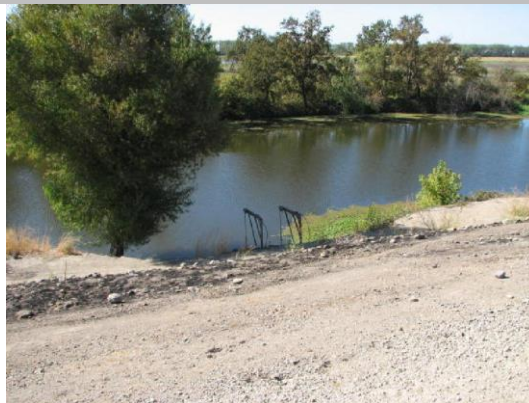
Photo 2 of 3 : UCIP\_SP\_2017\_51567\_64818.jpg

Flap gates on WS toe.

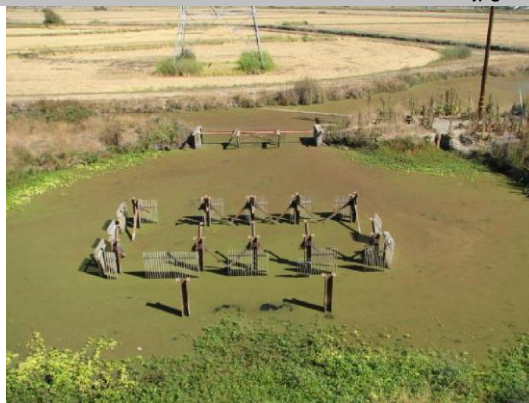
Photo 3 of 3 : UCIP\_SP\_2017\_51567\_64817.jpg

Abandoned pump house and sump on LS toe.

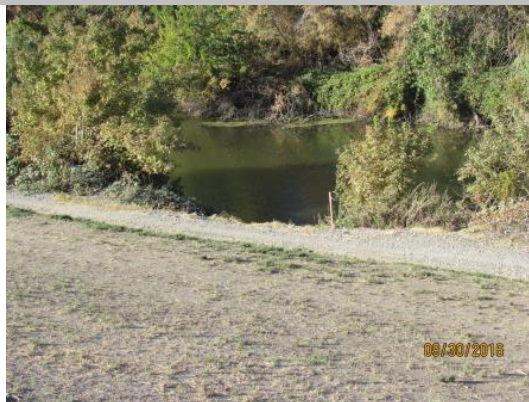
Photo 1 of 1 : SP\_2017\_ST0002\_450\_34\_20170315\_00009.jpg

LM Start	7.83	Rating **	A/W	Issue No.	34
LM End	7.83	Issue Type +	Ma	Location *	WS
Category	Earthen Levee			GPS Latitude/Longitude	
				Start	End
Item	Erosion / Bank Caving			39.067299 °	39.067299 °
				-121.742851 °	-121.742851 °
DWR ID	DWR_ST0002_01_f_2016_34

View of the erosion along the waterside toe.

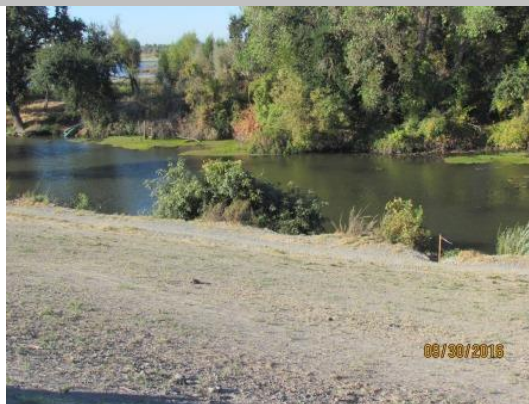
Photo 1 of 1 : SP\_2017\_ST0002\_450\_35\_20170315\_00010.jpg

View of the erosion along the waterside toe.

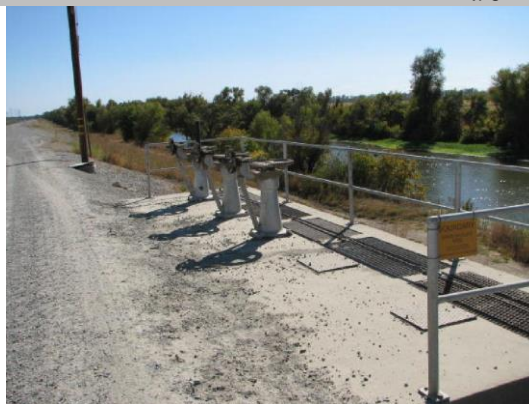
Photo 1 of 3 : UCIP\_SP\_2017\_51595\_65251.jpg

LM Start	10.83	Rating **	M	Issue No.	66
LM End	10.83	Issue Type +	Ma	Location *	WS
Category	Supplemental			GPS Latitude/Longitude	
				Start	End
Item	DWR UCIP LMA Responsibility			39.025693 °	39.025693 °
				-121.726895 °	-121.726895 °
DWR ID					
Comment Code					
Inspector Comment

Slide gates on WS shoulder

FS\_ID:51595  
DS\_ID:16871  
EP\_NO: N/A  
Repair Type: Non-Urgent  
Crossing Status: Found  
UCIP Comments: 4/11/2017 Abandoned.10/10/2016 Abandoned crossing.4/18/2016 Abandoned crossing but no noticeable issues seen with it.5/7/2015 Abandoned crossing but no noticeable issues with it.11/12/2014 Same as last inspection.5/13/2014 Same as last inspection.10/30/2013 Same as last inspection.5/22/2013 Same as last inspection.10/8/2012 Need to determine type of abandonment.  
FIELD\_STRUCT\_DESC: \*ABANDONED\* [Pumping Plant No. 2] 1 of 5.  
4-foot by 6-foot concrete drainage culvert through the levee, 31.5 feet below the crown. Wood flap gate and concrete headwall on the waterside (WS) end. Wooden steps on the landside (LS) slope. Concrete steps on the WS end. [Additional Reference(s): DWR Levee Log, 2005. USACE Sacramento O&M Manual 315, May 1953 (Station 582+19)]  
FS Date: 4/13/2017 2:16:54 PM

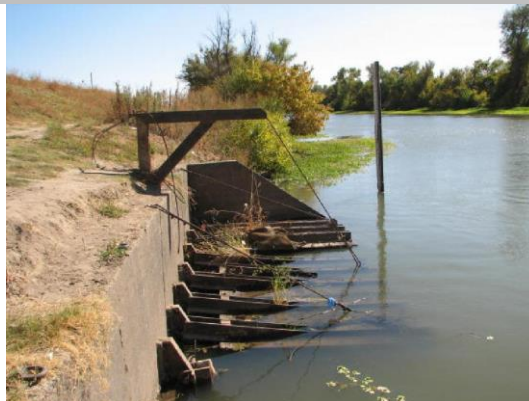
Photo 2 of 3 : UCIP\_SP\_2017\_51595\_65250.jpg

Flap gates on WS toe.

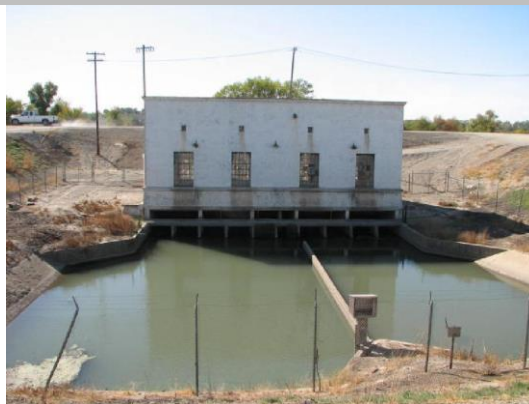
Photo 3 of 3 : UCIP\_SP\_2017\_51595\_65249.jpg

Pumphouse/intake structure on LS toe.

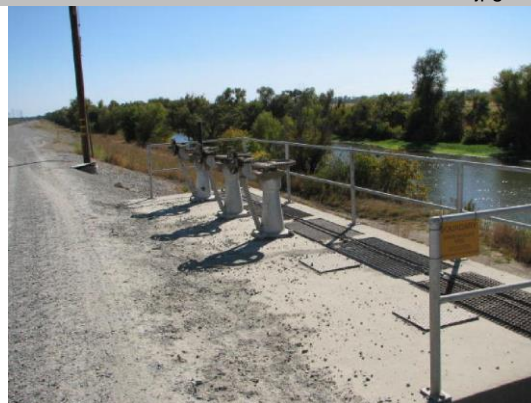
Photo 1 of 3 : UCIP\_SP\_2017\_51596\_65254.jpg

FS\_ID:51596  
DS\_ID:16906  
EP\_NO: N/A  
Repair Type: Non-Urgent  
Crossing Status: Found  
UCIP Comments: 4/11/2017 Abandoned.10/10/2016 Crossing appears to be in good condition. (DWR Sutter Yard - afreitag)4/18/2016 Abandoned crossing but no noticeable issues seen with it.5/7/2015 Abandoned crossing but no noticeable issues to report.11/12/2014 Same as last inspection.5/13/2014 Same as last inspection.10/30/2013 Same as last inspection.5/22/2013 Same as last inspection.10/8/2012 Determine type of abandonment.  
FIELD\_STRUCT\_DESC: \*ABANDONED\* [Pumping Plant No. 2] 2 of 5. 4-foot by 6-foot concrete drainage culvert through the levee, 31.5 feet below the crown. Wood flap gate and concrete headwall on the waterside (WS) end. Wooden steps on the landside (LS) slope. Concrete steps on the WS end. [Additional Reference(s): DWR Levee Log, 2005. USACE Sacramento O&M Manual 315, May 1953 (Station 582+19)]

Slide gates on WS shoulder.

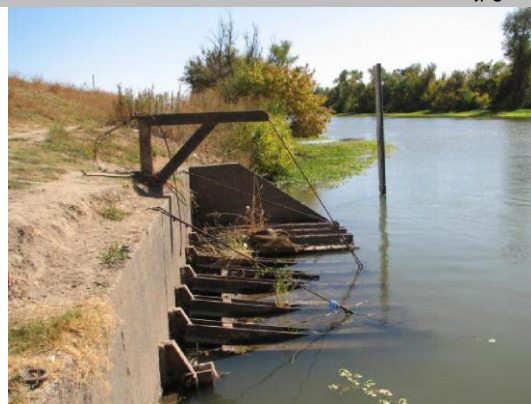
Photo 2 of 3 : UCIP\_SP\_2017\_51596\_65253.jpg

Flap gates on WS toe.

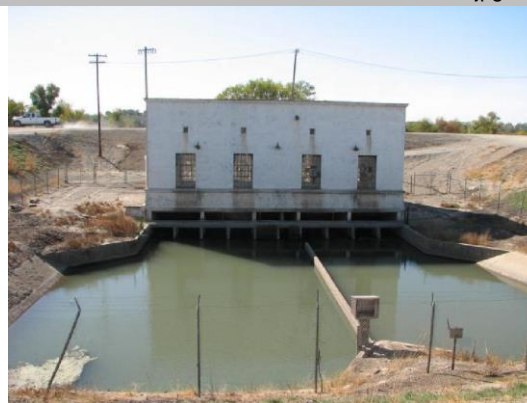
Photo 3 of 3 : UCIP\_SP\_2017\_51596\_65252.jpg

Pumping plant on LS toe.

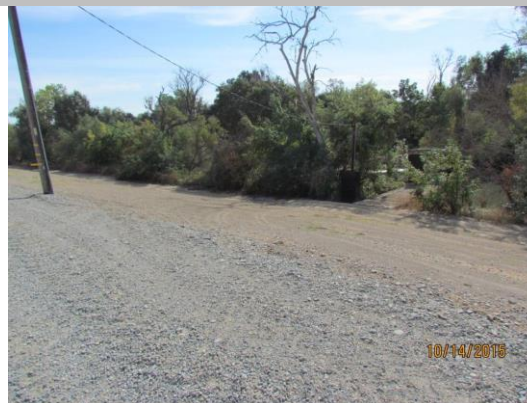
Photo 1 of 1 : SP\_2017\_ST0002\_450\_23\_20170315\_00004.jpg

LM Start	13.34	Rating **	A/W	Issue No.	23
LM End	13.34	Issue Type +	Ma	Location *	WS
Category	Earthen Levee			GPS Latitude/Longitude	
				Start	End
Item	Slope Stability			38.991857 °	38.991857 °
				-121.711555 °	-121.711555 °
DWR ID	DWR_ST0002_01_s_2015_23				
Comment Code					
S3 : Repair the levee slope damaged by vehicle traffic and prevent access where possible.					
Inspector Comment					
Repair the erosion along the waterside slope.

View of the vehicle erosion along the slope.

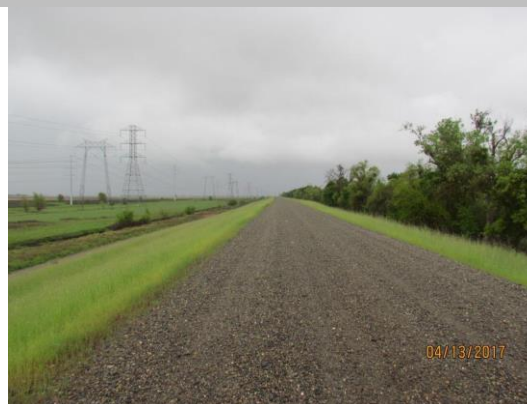
Photo 1 of 1 : SP\_2017\_ST0002\_450\_43\_20170413\_00070.jpg

LM Start	13.98	Rating **	A	Issue No.	43
LM End	13.98	Issue Type +	Ma	Location *	LS
Category	Earthen Levee			GPS Latitude/Longitude	
				Start	End
Item	Vegetation			38.985980 °	38.985980 °
				-121.702438 °	-121.702438 °
DWR ID	DWR_ST0002_01_s_2017_43				
Comment Code					
V1 : Control annual grass and weeds on the levee slopes and easements.					
Inspector Comment					
There are native grasses on both slopes.

View of native grasses on both slopes.

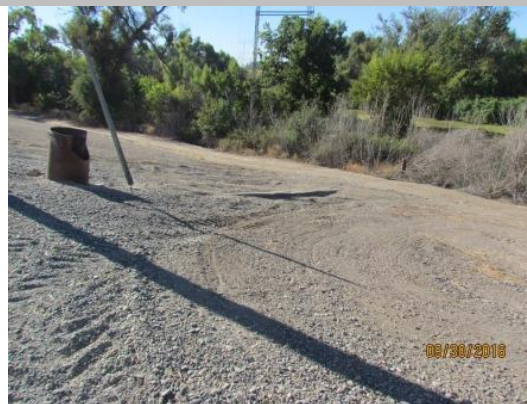
Photo 1 of 1 : SP\_2017\_ST0002\_450\_37\_20170315\_00011.jpg

LM Start	14.71	Rating **	M	Issue No.	37
LM End	14.71	Issue Type +	Ma	Location *	WS
Category	Earthen Levee			GPS Latitude/Longitude	
				Start	End
Item	Slope Stability			38.979389 °	38.979389 °
				-121.691923 °	-121.691923 °
DWR ID	DWR_ST0002_01_f_2016_37				
Comment Code					
S3 : Repair the levee slope damaged by vehicle traffic and prevent access where possible.					
Inspector Comment					
Repair the vehicle erosion along the waterside slope.

View of the erosion caused by vehicle traffic.

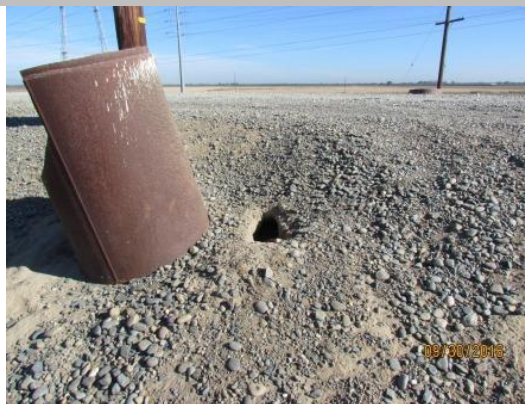
Photo 1 of 1 : SP\_2017\_ST0002\_450\_38\_20170315\_00012.jpg

View of the rodent holes along the landside slope.

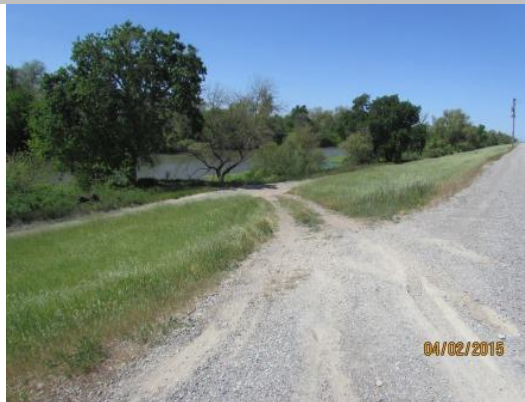
Photo 1 of 2 : SP\_2017\_ST0002\_450\_21\_20170315\_00002.jpg

LM Start	17.60	Rating **	M	Issue No.	21
LM End	17.60	Issue Type +	Ma	Location *	WS
Category	Earthen Levee			GPS Latitude/Longitude	
				Start	End
Item	Slope Stability			38.949965 °	38.949965 °
				-121.653823 °	-121.653823 °
DWR ID	DWR_ST0002_01_s_2015_21				
Comment Code					
S3 : Repair the levee slope damaged by vehicle traffic and prevent access where possible.					
Inspector Comment					
Repair the vehicle erosion along the waterside slope.

View of the vehicle erosion along the waterside slope.

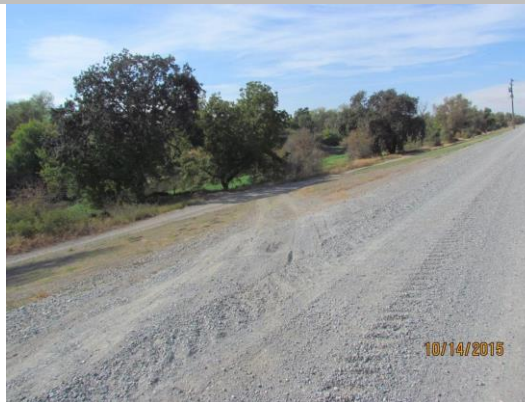
Photo 2 of 2 : SP\_2017\_ST0002\_450\_21\_20170315\_00003.jpg

View of the vehicle erosion along the waterside slope.

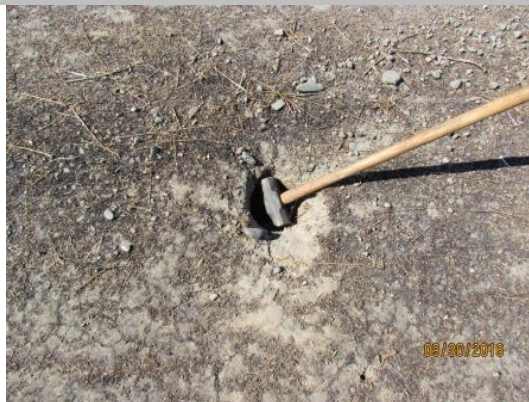
Photo 1 of 2 : SP\_2017\_ST0002\_450\_39\_20170315\_00013.jpg

LM Start	19.86	Rating **	U	Issue No.	39
LM End	19.86	Issue Type +	Ma	Location *	LS
Category	Earthen Levee			GPS Latitude/Longitude	
				Start	End
Item	Animal Control			38.924752 °	38.924752 °
				-121.627068 °	-121.627068 °
DWR ID	DWR ST0002 01 f 2016 39

View of a rodent hole with large hammer sitting on top.

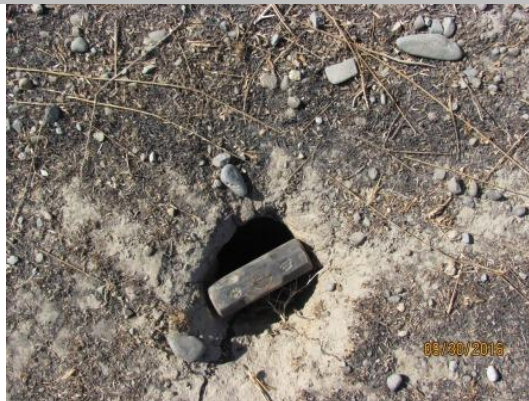
Photo 2 of 2 : SP\_2017\_ST0002\_450\_39\_20170315\_00014.jpg

Another view of the rodent hole with large hammer hanging in the hole.

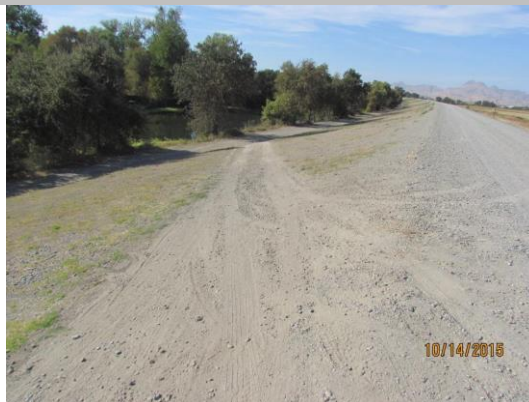
Photo 1 of 1 : SP\_2017\_ST0002\_450\_29\_20170315\_00007.jpg

LM Start	20.02	Rating **	M	Issue No.	29
LM End	20.02	Issue Type +	Ma	Location *	WS
Category	Earthen Levee			GPS Latitude/Longitude	
				Start	End
Item	Slope Stability			38.922678 °	38.922678 °
				-121.625890 °	-121.625890 °
DWR ID	DWR_ST0002_01_f_2015_29				
Comment Code					
S3 : Repair the levee slope damaged by vehicle traffic and prevent access where possible.					
Inspector Comment

View of the vehicle erosion along the waterside slope.

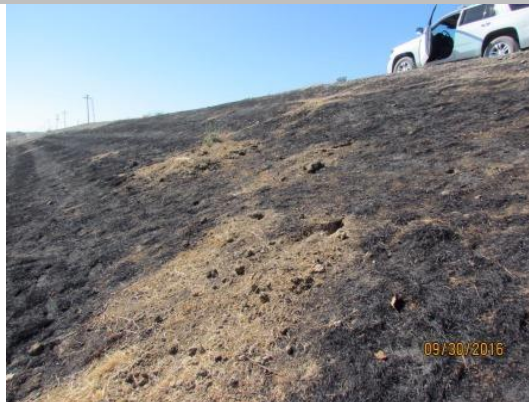
Photo 1 of 1 : SP\_2017\_ST0002\_450\_40\_20170315\_00015.jpg

View of the rodent holes along the landside slope.
